**Flood Control Project Maintenance
Levee Inspections**
LMA District Cover Sheet
Spring 2019 Levee Inspection Results

Reclamation District No. 2092 Dos Rios

Spring 2019 Levee Inspection Results

| Waterway | | | Bank | Unit Miles |
|--|---|---|---|---|
| Unit No. 01 San Joaquin River | | | Right | 3.71 |

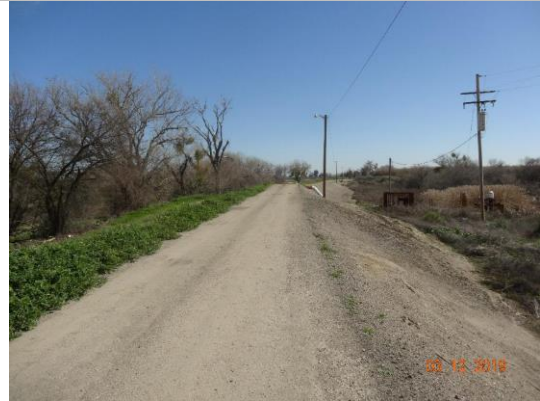
Photo 1 of 3 : UCIP_SP_2019_53815_79066.jpg

Overview of levee looking d/s towards crossing.

| FS_ID:53815 DS_ID:20581 EP_NO: 6254A Repair Type: Non-Urgent Crossing Status: Found UCIP Comments: 03/12/2019 Pipe has been altered on both WS and LS. A PVC pipe has been sleeved through an existing 22-inch pipe, no records have been found approving modification. This crossing appears abandoned, power source and power meter have been disconnected. Need to coordinate with CVFPB and owner. Crossing should be removed/abandoned properly per Title 23. (O. Magana - DWR UCIP) FIELD_STRUCT_DESC: *ABANDONED* 22-inch steel drainage pipe through the levee, 0.5 feet below the crown. 18-inch polyvinyl chloride (PVC) pipe sleeved through the 22-inch steel pipe. 6-inch pad constructed over the pipes. This pumping plant was constructed in 1969 during emergency conditions without a permit. Replaced a 20-inch pipe at the same location. [Additional Reference(s): DWR Levee Log, 2005]. FS Date: 3/12/2019 12:05:00 PM | | | | | |

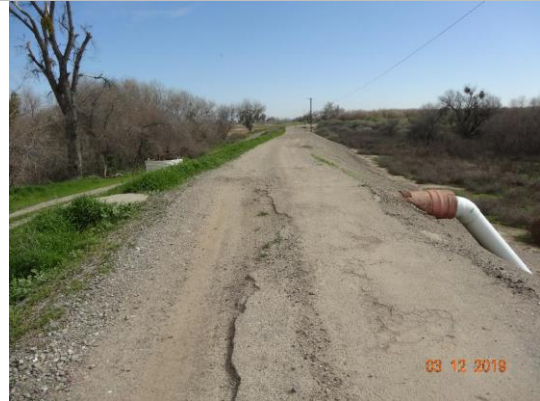
Photo 3 of 3 : UCIP_SP_2019_53815_79064.jpg

Overview of levee crown at pipe crossing, photo taking looking d/s.

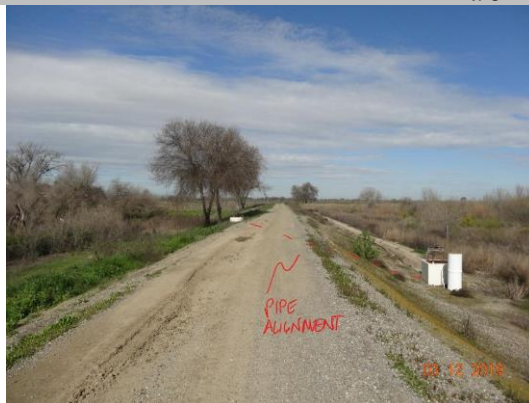
Photo 1 of 3 : UCIP_SP_2019_53820_79073.jpg

| FS_ID:53820 DS_ID:20562 EP_NO: N/A Repair Type: Non-Urgent Crossing Status: Found UCIP Comments: 03/12/2019 During UCIP visual inspection, no pipe or levee integrity issues were observed. Distribution box located on the WS is falling apart (bricks missing). This crossing is an active crossing however, no permit has been found authorizing crossing. Need to determine who maintains and operates this crossing. (O. Magana - DWR UCIP) FIELD_STRUCT_DESC: 36-inch corrugated metal drainage pipe through the levee, 15 feet below the crown. Slide gate in a 48-inch corrugated metal pipe (CMP) riser on the waterside (WS) slope. 4-foot by 6-foot concrete distribution box on the landside (LS) toe. 5-foot by 5-foot concrete riser on the WS toe. [Additional Reference(s): DWR Levee Log, 2005. USACE San Joaquin O&M Manual 5, August 1961, (HLM 1.31)]. FS Date: 3/12/2019 12:06:00 PM | | | | | | |

Overview of pipe alignment through levee, photo taking looking d/s toward crossing.

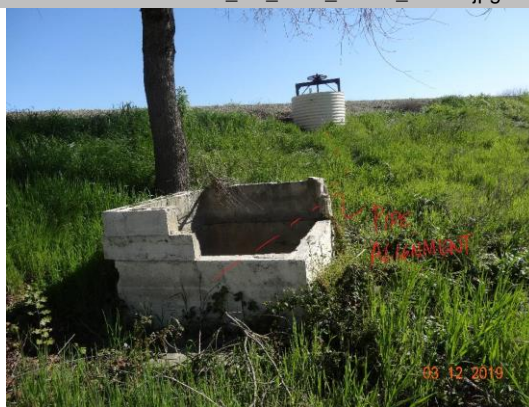
Photo 2 of 3 : UCIP_SP_2019_53820_79078.jpg

WS view: approximate alignment on WS.

| FS_ID:53820 DS_ID:20562 EP_NO: N/A Repair Type: Non-Urgent Crossing Status: Found UCIP Comments: 03/12/2019 During UCIP visual inspection, no pipe or levee integrity issues were observed. Distribution box located on the WS is falling apart (bricks missing). This crossing is an active crossing however, no permit has been found authorizing crossing. Need to determine who maintains and operates this crossing. (O. Magana - DWR UCIP) FIELD_STRUCT_DESC: 36-inch corrugated metal drainage pipe through the levee, 15 feet below the crown. Slide gate in a 48-inch corrugated metal pipe (CMP) riser on the waterside (WS) slope. 4-foot by 6-foot concrete distribution box on the landside (LS) toe. 5-foot by 5-foot concrete riser on the WS toe. [Additional Reference(s): DWR Levee Log, 2005. USACE San Joaquin O&M Manual 5, August 1961, (HLM 1.31)]. FS Date: 3/12/2019 12:06:00 PM | | | | | | |

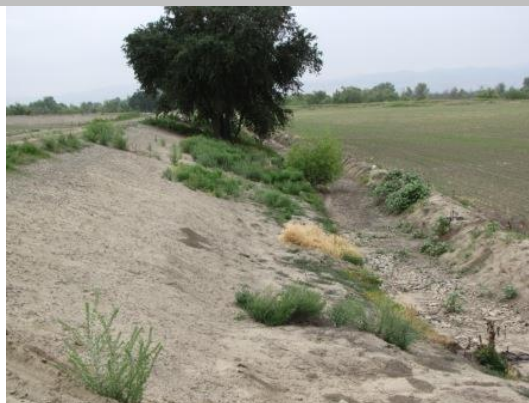
Photo 1 of 1 : SP_2019_RD2092_116_8_20190307_00001.jpg

View of an agricultural ditch at the waterward toe of the slope.

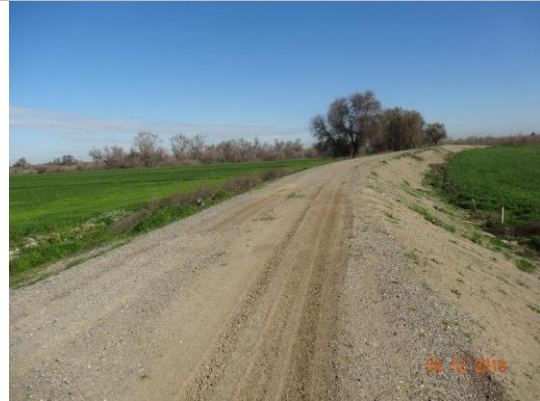
Photo 1 of 3 : UCIP_SP_2019_53817_79086.jpg

| FS_ID:53817 DS_ID:20563 EP_NO: N/A Repair Type: Urgent Crossing Status: Found UCIP Comments: 03/12/2019 A thorough internal evaluation of this crossing is required, pipe shows evidence of pipe integrity (LS) issues (pipe wall sections missing on WS outlet). Internal inspection is recommended for this crossing to determine the extent of pipe damage through the levee. Maintenance issues identified at this crossing include: flap gate missing on WS, debris found inside concrete distribution box, and missing cover on riser. No permit has been identified for this crossing. Need to determine who maintains crossing; crossing appears functional. (O. Magana - DWR UCIP) FIELD_STRUCT_DESC: 24-inch corrugated metal drainage pipe through the levee, 14 feet below the crown. Slide gate in a corrugated metal pipe (CMP) riser on the waterside (WS) slope. Concrete U-shaped headwall at the landside (LS) toe. [Additional Reference(s): DWR Levee Log, 2005. USACE San Joaquin O&M Manual 5, August 1961, (HLM 1.71)]. FS Date: 3/12/2019 12:07:00 PM | | | | | |

Overview of levee crown looking d/s towards pipe crossing.

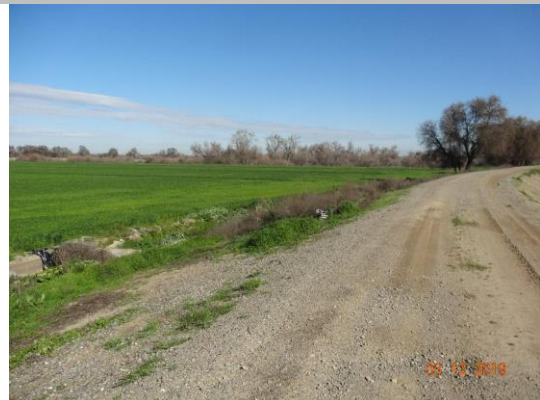
Photo 2 of 3 : UCIP_SP_2019_53817_79087.jpg

WS view: overview of WS.

| FS_ID:53817 DS_ID:20563 EP_NO: N/A Repair Type: Urgent Crossing Status: Found UCIP Comments: 03/12/2019 A thorough internal evaluation of this crossing is required, pipe shows evidence of pipe integrity (LS) issues (pipe wall sections missing on WS outlet). Internal inspection is recommended for this crossing to determine the extent of pipe damage through the levee. Maintenance issues identified at this crossing include: flap gate missing on WS, debris found inside concrete distribution box, and missing cover on riser. No permit has been identified for this crossing. Need to determine who maintains crossing; crossing appears functional. (O. Magana - DWR UCIP) FIELD_STRUCT_DESC: 24-inch corrugated metal drainage pipe through the levee, 14 feet below the crown. Slide gate in a corrugated metal pipe (CMP) riser on the waterside (WS) slope. Concrete U-shaped headwall at the landside (LS) toe. [Additional Reference(s): DWR Levee Log, 2005. USACE San Joaquin O&M Manual 5, August 1961, (HLM 1.71)]. FS Date: 3/12/2019 12:07:00 PM | | | | | | |

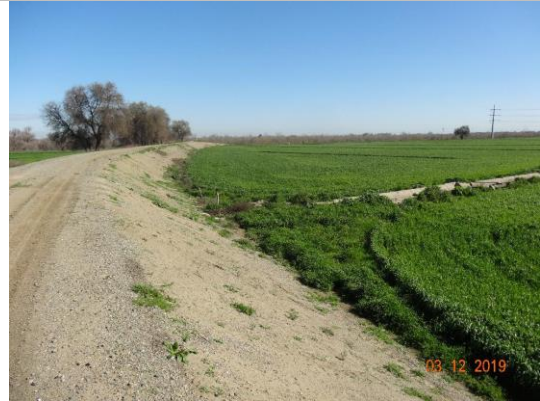
Photo 3 of 3 : UCIP_SP_2019_53817_79085.jpg

LS view: overview of LS.

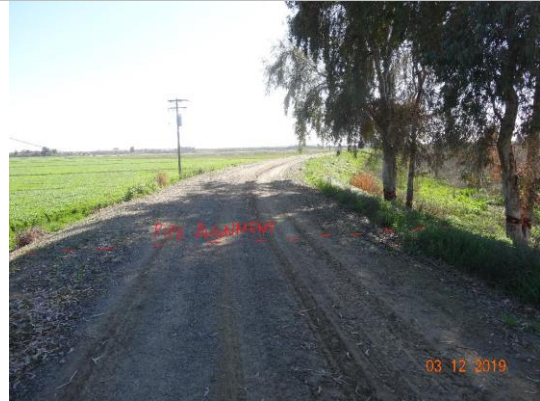
Photo 1 of 3 : UCIP_SP_2019_53814_79091.jpg

FS_ID:53814
DS_ID:20564
EP_NO: N/A
Repair Type: Non-Urgent
Crossing Status: Found
UCIP Comments: 03/12/2019 Concrete headwall found on LS toe. Pipe appears to have been grouted through. No other appurtenances were found during inspection. WS outlet was not found. Need to coordinate with the CVFPB to determine if additional steps are needed to comply with Title 23. (O. Magana - DWR UCIP)
FIELD_STRUCT_DESC: *ABANDONED* 30-inch corrugated metal drainage pipe through the levee, 15 feet below the crown. Flap gate on the waterside (WS) end. Concrete U-shaped headwalls on both ends. Filled with concrete on the landside (LS) toe. [Additional Reference(s): DWR Levee Log, 2005. USACE San Joaquin O&M Manual 5, August 1961, (HLM 2.10), 36-inch pipe listed].
FS Date: 3/12/2019 12:08:00 PM

Overview of levee crown, looking u/s from d/s, and approximate pipe alignment.

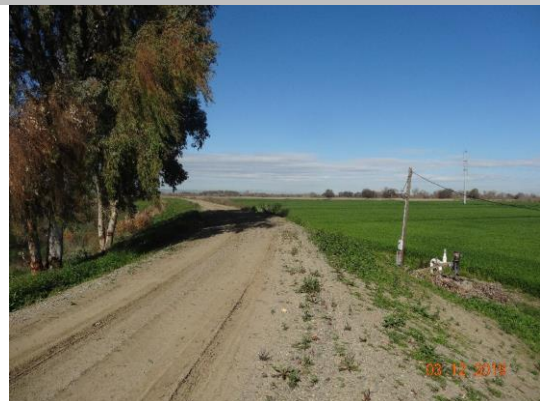
Photo 2 of 3 : UCIP_SP_2019_53814_79092.jpg

Overview of levee at crossing, photo taken u/s looking d/s towards pipe crossing.

| FS_ID:53814 DS_ID:20564 EP_NO: N/A Repair Type: Non-Urgent Crossing Status: Found UCIP Comments: 03/12/2019 Concrete headwall found on LS toe. Pipe appears to have been grouted through. No other appurtenances were found during inspection. WS outlet was not found. Need to coordinate with the CVFPB to determine if additional steps are needed to comply with Title 23. (O. Magana - DWR UCIP) FIELD_STRUCT_DESC: *ABANDONED* 30-inch corrugated metal drainage pipe through the levee, 15 feet below the crown. Flap gate on the waterside (WS) end. Concrete U-shaped headwalls on both ends. Filled with concrete on the landside (LS) toe. [Additional Reference(s): DWR Levee Log, 2005. USACE San Joaquin O&M Manual 5, August 1961, (HLM 2.10), 36-inch pipe listed]. FS Date: 3/12/2019 12:08:00 PM | | | | | | |

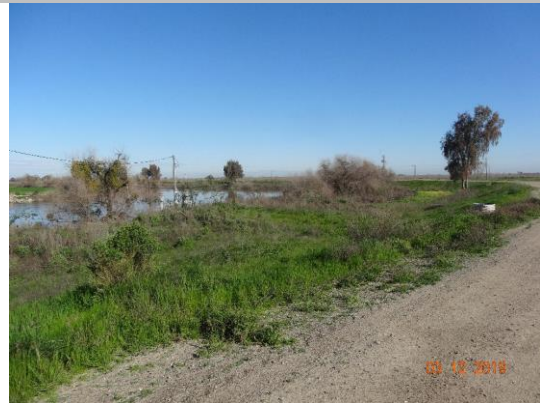
Photo 1 of 3 : UCIP_SP_2019_53805_79106.jpg

| FS_ID:53805 DS_ID:24680 EP_NO: N/A Repair Type: Non-Urgent Crossing Status: Found UCIP Comments: 03/12/2019 No permit was found authorizing modifications to existing crossing. New crossing was added at this levee section using the old appurtenances associated with USACE O&M Legacy system Pipe (dsid 20566). The pipe associated with dsid 20566 has been grouted through (see dsid 20566 detail report). Irrigation pipe is functional and pipe is being maintained. Unable to confirm if riser located on WS is being used with this crossing. Need to coordinate with CVFPB to determine owner and if permit was issued for the modifications of this crossing. (O. Magana - DWR UCIP) 09/24/2013 No permit identified for this crossing. (W. Wylie - DWR UCIP) FIELD_STRUCT_DESC: 21-inch polyvinyl chloride (PVC) irrigation pipe through the levee, at an unknown depth. Pipe discharges into a concrete distribution box on the landside (LS) toe. Pump on pier off the waterside (WS) toe. [Additional Reference(s): DWR Levee Log, 2005]. FS Date: 3/12/2019 12:08:00 PM | | | | | |

WS view: overview of WS.

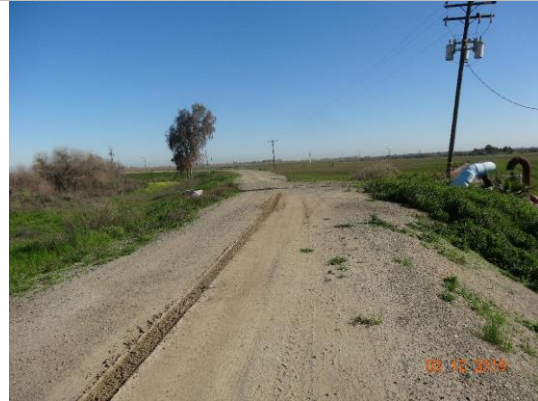
Photo 2 of 3 : UCIP_SP_2019_53805_79105.jpg

| FS_ID:53805 DS_ID:24680 EP_NO: N/A Repair Type: Non-Urgent Crossing Status: Found UCIP Comments: 03/12/2019 No permit was found authorizing modifications to existing crossing. New crossing was added at this levee section using the old appurtenances associated with USACE O&M Legacy system Pipe (dsid 20566). The pipe associated with dsid 20566 has been grouted through (see dsid 20566 detail report). Irrigation pipe is functional and pipe is being maintained. Unable to confirm if riser located on WS is being used with this crossing. Need to coordinate with CVFPB to determine owner and if permit was issued for the modifications of this crossing. (O. Magana - DWR UCIP) 09/24/2013 No permit identified for this crossing. (W. Wylie - DWR UCIP) FIELD_STRUCT_DESC: 21-inch polyvinyl chloride (PVC) irrigation pipe through the levee, at an unknown depth. Pipe discharges into a concrete distribution box on the landside (LS) toe. Pump on pier off the waterside (WS) toe. [Additional Reference(s): DWR Levee Log, 2005]. FS Date: 3/12/2019 12:08:00 PM | | | | | | |

Overview of levee crown looking d/s towards crossing.

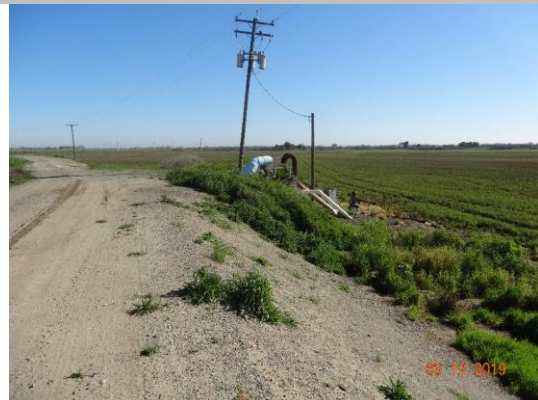
Photo 3 of 3 : UCIP_SP_2019_53805_79104.jpg

LS view: overview of LS.

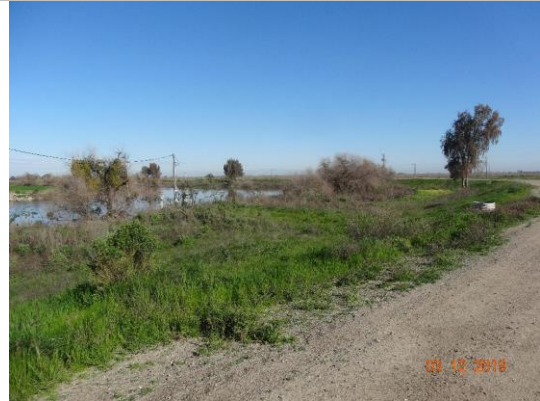
Photo 1 of 3 : UCIP_SP_2019_54051_79112.jpg

| FS_ID:54051 DS_ID:20566 EP_NO: N/A Repair Type: Non-Urgent Crossing Status: Found UCIP Comments: 03/12/2019 Concrete distribution box found on LS with evidence that 24-inch pipe was going through levee. Pipe appears to have been grouted through. Riser is still present on WS however, unable to determine if pipe was grouted all the way through the levee section. Concrete distribution box is currently being used by an unauthorized pipe encroachment (see DSID 24680). Lid missing from CMP riser. Owner needs to add lid to riser to prevent entry in confined space. Need to coordinate with the CVFPB to determine how to address abandoned appurtenances and pipe abandonment. (O. Magana - DWR UCIP) 09/24/2013 Pipe appears abandoned and needs to be verified as having been done so properly. (W. Wylie - DWR UCIP) FIELD_STRUCT_DESC: *ABANDONED* 24-inch corrugated metal irrigation pipe through the levee, 11 feet below the crown. Slide gate in a 36-inch corrugated metal pipe (CMP) riser on the waterside (WS) slope. 5-foot by 5-foot concrete distribution box on the landside (LS). Pump on platform in the channel. Pipe filled with concrete on the LS toe. [Additional Reference(s): DWR Levee Log, 2005. USACE San Joaquin O&M Manual 5, August 1961, (HLM 2.38)]. FS Date: 3/12/2019 12:09:00 PM | | | | | |

WS view: overview of WS.

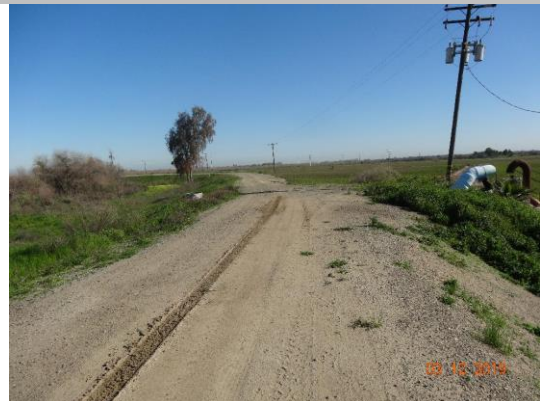
Photo 2 of 3 : UCIP_SP_2019_54051_79111.jpg

Overview of levee crown looking d/s looking towards crossing.

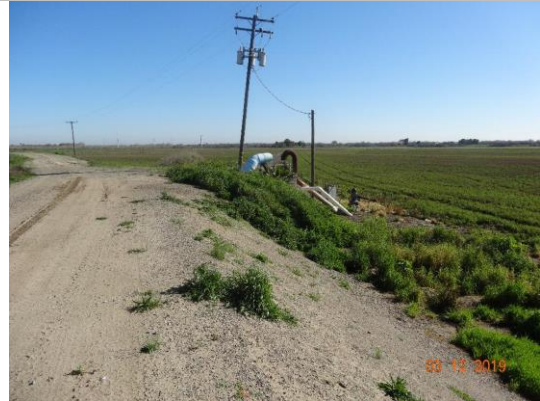
Photo 3 of 3 : UCIP_SP_2019_54051_79110.jpg

| FS_ID:54051 DS_ID:20566 EP_NO: N/A Repair Type: Non-Urgent Crossing Status: Found UCIP Comments: 03/12/2019 Concrete distribution box found on LS with evidence that 24-inch pipe was going through levee. Pipe appears to have been grouted through. Riser is still present on WS however, unable to determine if pipe was grouted all the way through the levee section. Concrete distribution box is currently being used by an unauthorized pipe encroachment (see DSID 24680). Lid missing from CMP riser. Owner needs to add lid to riser to prevent entry in confined space. Need to coordinate with the CVFPB to determine how to address abandoned appurtenances and pipe abandonment. (O. Magana - DWR UCIP) 09/24/2013 Pipe appears abandoned and needs to be verified as having been done so properly. (W. Wylie - DWR UCIP) FIELD_STRUCT_DESC: *ABANDONED* 24-inch corrugated metal irrigation pipe through the levee, 11 feet below the crown. Slide gate in a 36-inch corrugated metal pipe (CMP) riser on the waterside (WS) slope. 5-foot by 5-foot concrete distribution box on the landside (LS). Pump on platform in the channel. Pipe filled with concrete on the LS toe. [Additional Reference(s): DWR Levee Log, 2005. USACE San Joaquin O&M Manual 5, August 1961, (HLM 2.38)]. FS Date: 3/12/2019 12:09:00 PM | | | | | | |

LS view: overview of LS.

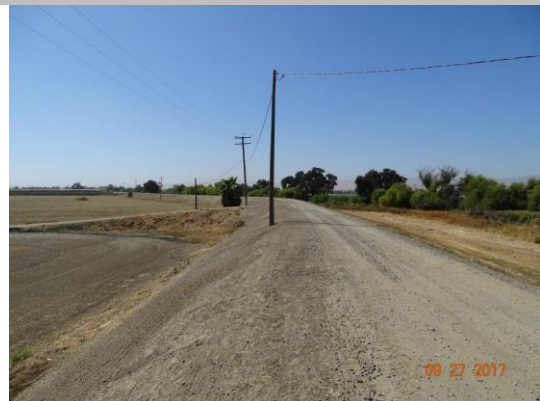
Photo 1 of 1 : SP_2019_RD2092_116_20_20190307_00010.jpg

View of the pole on the landside slope of the levee looking upstream.

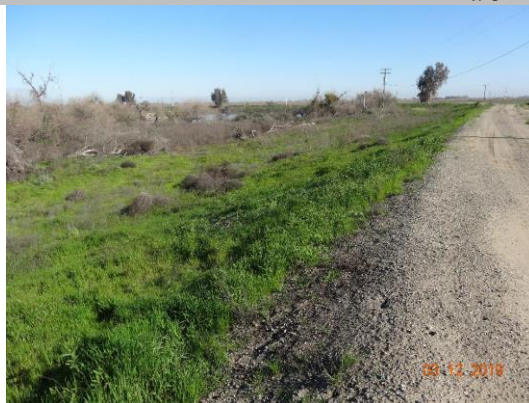
Photo 1 of 3 : UCIP_SP_2019_54052_79119.jpg

| FS_ID:54052 DS_ID:20567 EP_NO: N/A Repair Type: Non-Urgent Crossing Status: Indicator Found UCIP Comments: 03/12/2019 Unable to locate concrete headwall on the WS due to high water. Unable to locate concrete headwall on LS due to dense vegetation. No permit was found authorizing crossing. If crossing is no longer in use recommend removing crossing and appurtenances from levee. Need to coordinate with CVFPB to determine pipe owner. (O. Magana - DWR UCIP) 09/24/2013 Appears abandoned and if so should be done so properly. (W. Wylie - DWR UCIP) FIELD_STRUCT_DESC: *ABANDONED* 24-inch corrugated metal drainage pipe through the levee, 15 feet below the crown. Flap gate on the waterside (WS) end. Concrete U-shaped headwall on the WS end. Concrete headwall on the landside (LS) toe next to pump. [Additional Reference(s): DWR Levee Log, 2005. USACE San Joaquin O&M Manual 5, August 1961, (HLM 2.44)]. FS Date: 3/12/2019 12:09:00 PM | | | | | | |

WS view: overview of WS.

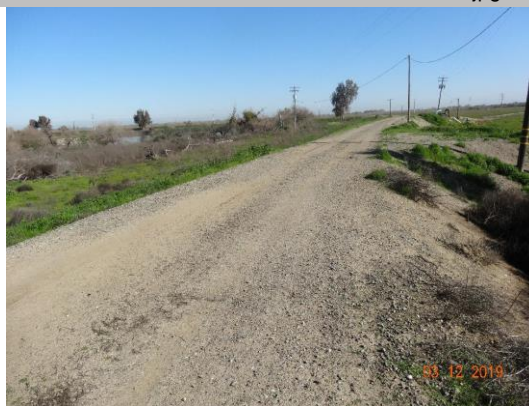
Photo 2 of 3 : UCIP_SP_2019_54052_79118.jpg

Overview of levee crown looking d/s towards crossing.

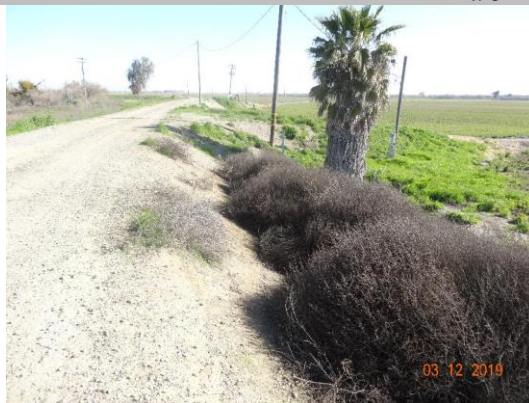
Photo 3 of 3 : UCIP_SP_2019_54052_79117.jpg

| FS_ID:54052 DS_ID:20567 EP_NO: N/A Repair Type: Non-Urgent Crossing Status: Indicator Found UCIP Comments: 03/12/2019 Unable to locate concrete headwall on the WS due to high water. Unable to locate concrete headwall on LS due to dense vegetation. No permit was found authorizing crossing. If crossing is no longer in use recommend removing crossing and appurtenances from levee. Need to coordinate with CVFPB to determine pipe owner. (O. Magana - DWR UCIP) 09/24/2013 Appears abandoned and if so should be done so properly. (W. Wylie - DWR UCIP) FIELD_STRUCT_DESC: *ABANDONED* 24-inch corrugated metal drainage pipe through the levee, 15 feet below the crown. Flap gate on the waterside (WS) end. Concrete U-shaped headwall on the WS end. Concrete headwall on the landside (LS) toe next to pump. [Additional Reference(s): DWR Levee Log, 2005. USACE San Joaquin O&M Manual 5, August 1961, (HLM 2.44)]. FS Date: 3/12/2019 12:09:00 PM | | | | | | |

LS view: overview of LS.

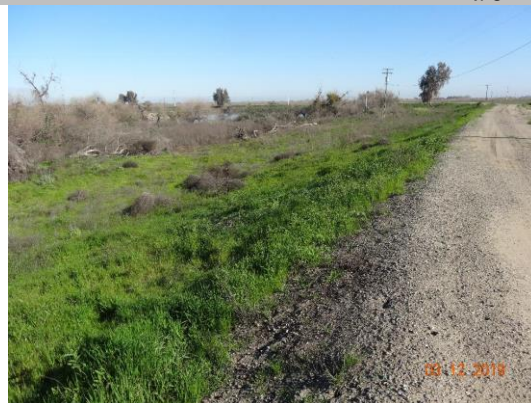
Photo 1 of 3 : UCIP_SP_2019_53808_79126.jpg

| FS_ID:53808 DS_ID:20568 EP_NO: N/A Repair Type: Non-Urgent Crossing Status: Indicator Found UCIP Comments: 03/12/2019 No permit was found authorizing crossing. Crossing appears to be abandoned, if crossing is abandoned, owner will need to coordinate with CVFPB to comply with Title 23. (O. Magana - DWR UCIP) 09/24/2013 Pipe abandoned and should be verified as having been removed from the levee. (W. Wylie - DWR UCIP) FIELD_STRUCT_DESC: *ABANDONED* 4-inch drainage pipe of an unknown material through the levee, 1 foot below the crown. Pump on sump at the landside (LS) toe. Roadway extending to the LS pump. [Additional Reference(s): DWR Levee Log, 2005]. FS Date: 3/12/2019 12:10:00 PM | | | | | |

WS view: overview of WS.

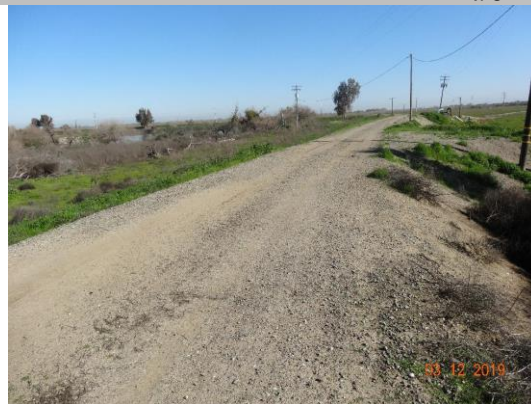
Photo 2 of 3 : UCIP_SP_2019_53808_79125.jpg

Overview of levee crown.

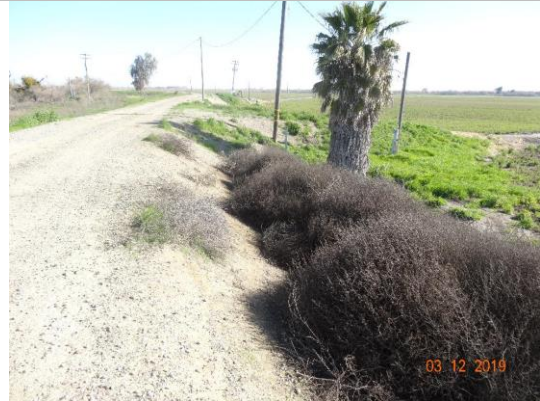
Photo 3 of 3 : UCIP_SP_2019_53808_79124.jpg

| FS_ID:53808 DS_ID:20568 EP_NO: N/A Repair Type: Non-Urgent Crossing Status: Indicator Found UCIP Comments: 03/12/2019 No permit was found authorizing crossing. Crossing appears to be abandoned, if crossing is abandoned, owner will need to coordinate with CVFPB to comply with Title 23. (O. Magana - DWR UCIP) 09/24/2013 Pipe abandoned and should be verified as having been removed from the levee. (W. Wylie - DWR UCIP) FIELD_STRUCT_DESC: *ABANDONED* 4-inch drainage pipe of an unknown material through the levee, 1 foot below the crown. Pump on sump at the landside (LS) toe. Roadway extending to the LS pump. [Additional Reference(s): DWR Levee Log, 2005]. FS Date: 3/12/2019 12:10:00 PM | | | | | | |

LS view: overview of LS.

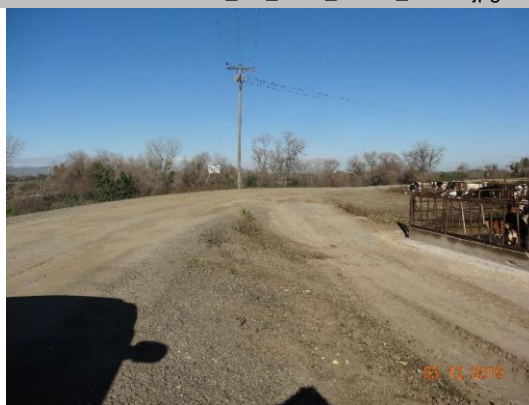
Photo 1 of 3 : UCIP_SP_2019_53813_79128.jpg

| FS_ID:53813 DS_ID:20569 EP_NO: N/A Repair Type: Non-Urgent Crossing Status: Not Found UCIP Comments: 03/12/2019 Need to confirm fate of crossing through levee section. (O. Magana - DWR UCIP) FIELD_STRUCT_DESC: 24-inch corrugated metal drainage pipe through the levee, 6 feet below the crown. Concrete U-shaped headwall and flap gate on the waterside (WS) end. [Additional Reference(s): DWR Levee Log, 2005. USACE San Joaquin O&M Manual 5, August 1961, (HLM 2.83)]. FS Date: 3/12/2019 12:10:00 PM | | | | | |

LS view: overview of LS.

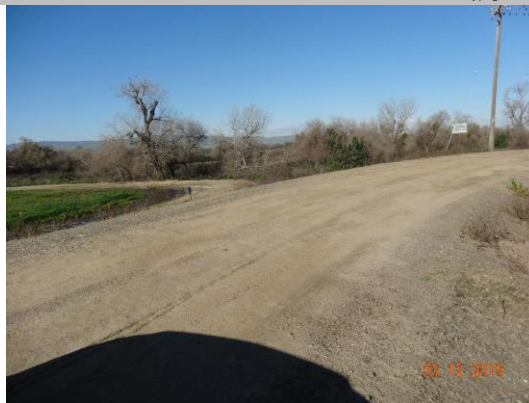
Photo 2 of 3 : UCIP_SP_2019_53813_79129.jpg

| FS_ID:53813 DS_ID:20569 EP_NO: N/A Repair Type: Non-Urgent Crossing Status: Not Found UCIP Comments: 03/12/2019 Need to confirm fate of crossing through levee section. (O. Magana - DWR UCIP) FIELD_STRUCT_DESC: 24-inch corrugated metal drainage pipe through the levee, 6 feet below the crown. Concrete U-shaped headwall and flap gate on the waterside (WS) end. [Additional Reference(s): DWR Levee Log, 2005. USACE San Joaquin O&M Manual 5, August 1961, (HLM 2.83)]. FS Date: 3/12/2019 12:10:00 PM | | | | | | |

Overview of levee crown where crossing should be.

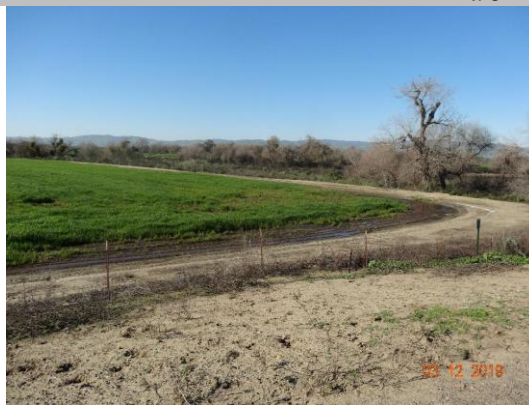
Photo 3 of 3 : UCIP_SP_2019_53813_79130.jpg

WS view: overview of WS.

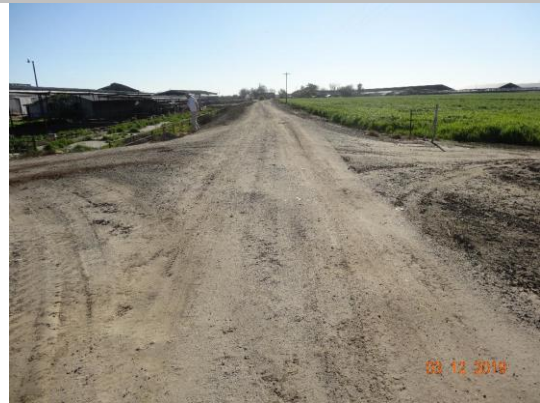
Photo 1 of 3 : UCIP_SP_2019_53810_79135.jpg

| FS_ID:53810 DS_ID:20570 EP_NO: N/A Repair Type: Non-Urgent Crossing Status: Indicator Found UCIP Comments: 03/12/2019 Unable to locate concrete headwall on the WS. Concrete headwall is still visible on the LS however, this crossing appears to be abandoned. No permit was found authorizing crossing. If crossing is no longer in use recommend removing crossing and appurtenances from levee. (O. Magana - DWR UCIP) 09/24/2013 Appears abandoned and if so, should be done so properly. (W. Wylie - DWR UCIP) FIELD_STRUCT_DESC: *ABANDONED* 24-inch corrugated metal drainage pipe through the levee, 6.5 feet below the crown. Concrete U-shaped headwall and flap gate on the waterside (WS) end. Concrete headwall on the landside (LS) slope. [Additional Reference(s): DWR Levee Log, 2005. USACE San Joaquin O&M Manual 5, August 1961]. FS Date: 3/12/2019 12:11:00 PM | | | | | |

Overview of levee at crossing, photo taken d/s looking u/s towards crossing.

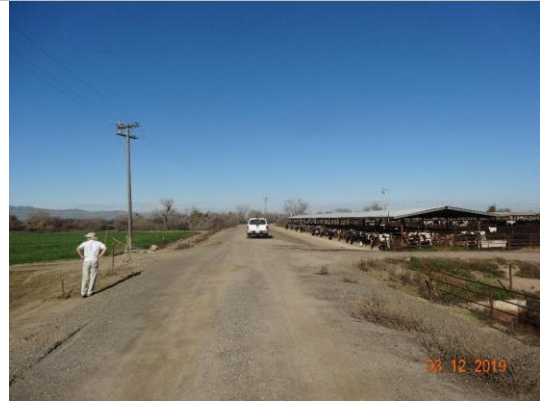
Photo 2 of 3 : UCIP_SP_2019_53810_79136.jpg

Overview of levee at crossing, photo taken u/s looking d/s towards crossing.

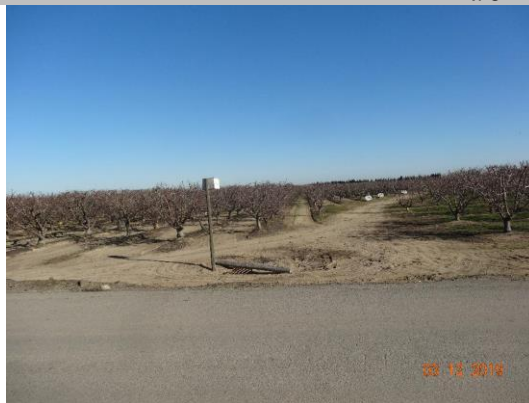
Photo 3 of 3 : UCIP_SP_2019_53786_79144.jpg

LS view: overview of land use on LS.
